South Dublin  
County Council

# Case Study: Saggart Schoolhouse Community Centre

JUNE 2025

Presented by  
Aidan McNamara

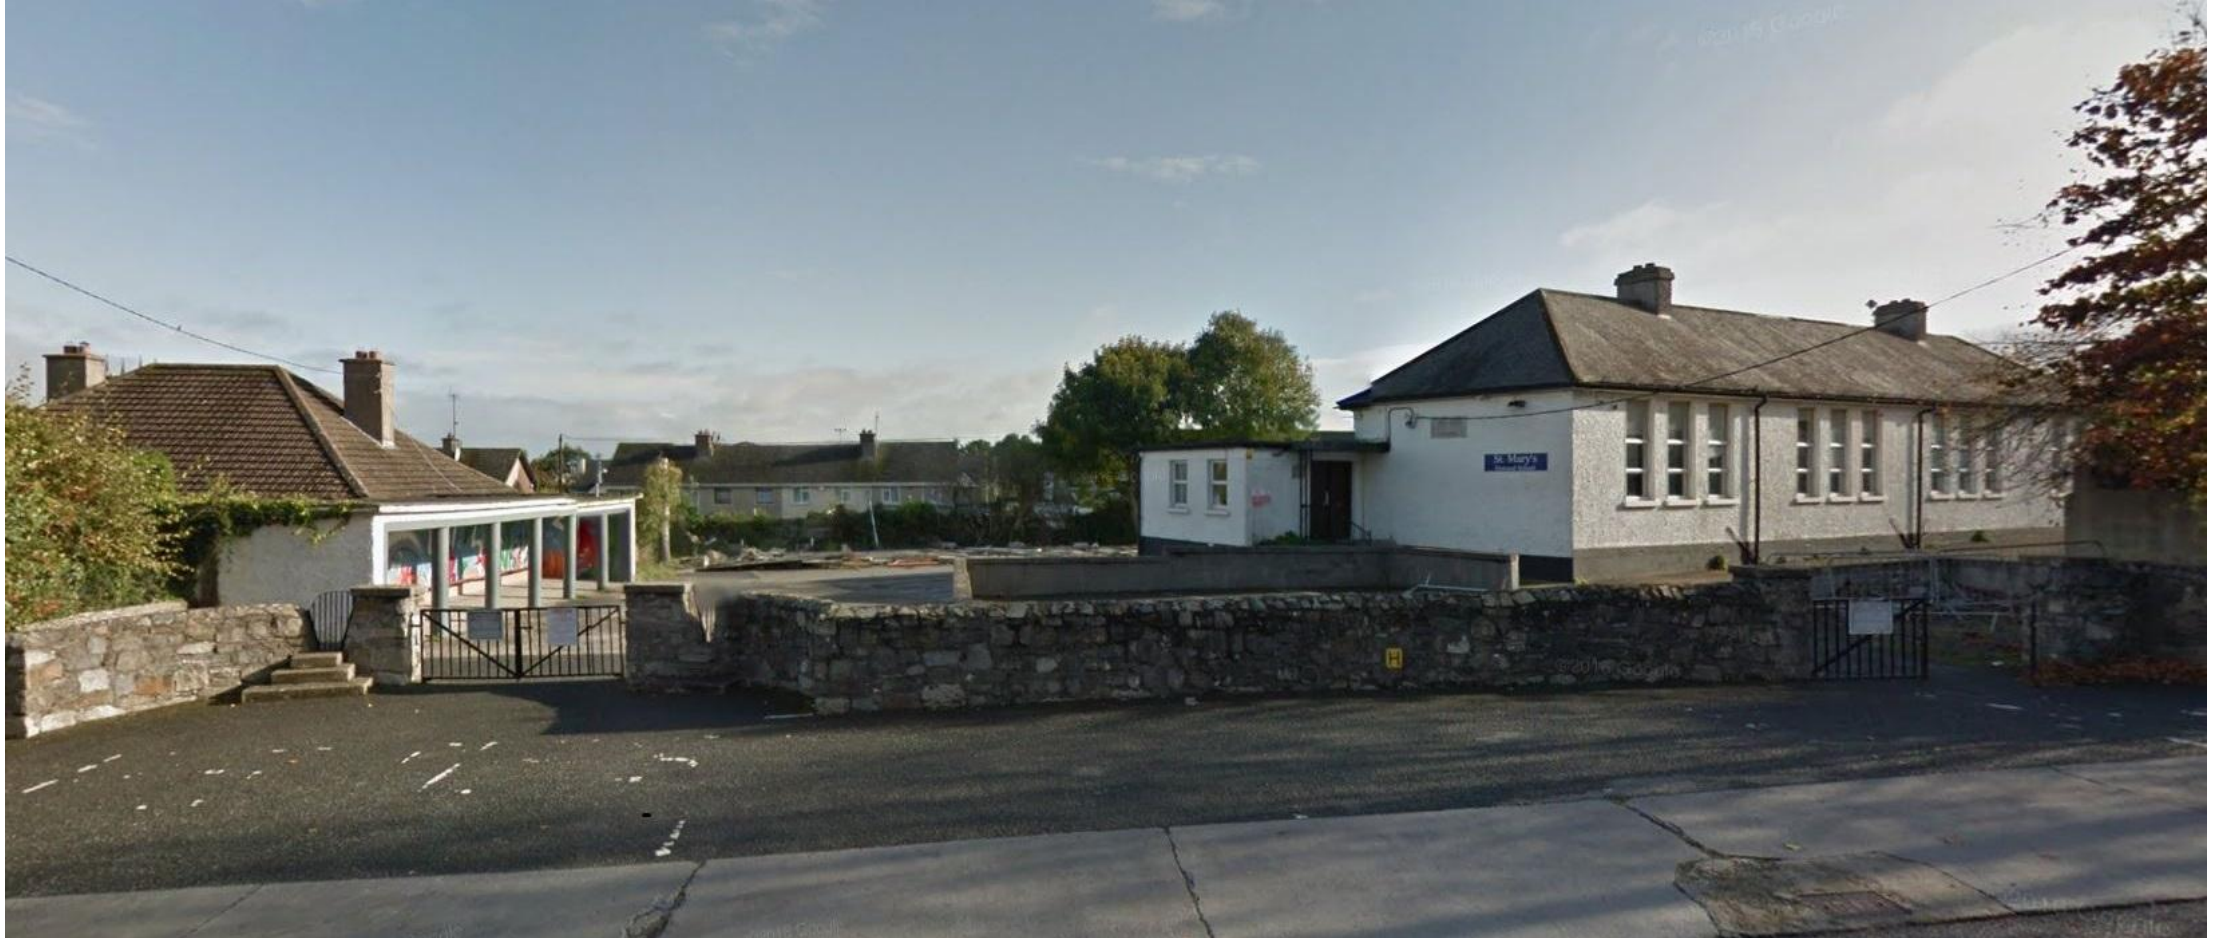
St. Mary's National School doesn't address the road, sitting around the corner of the site

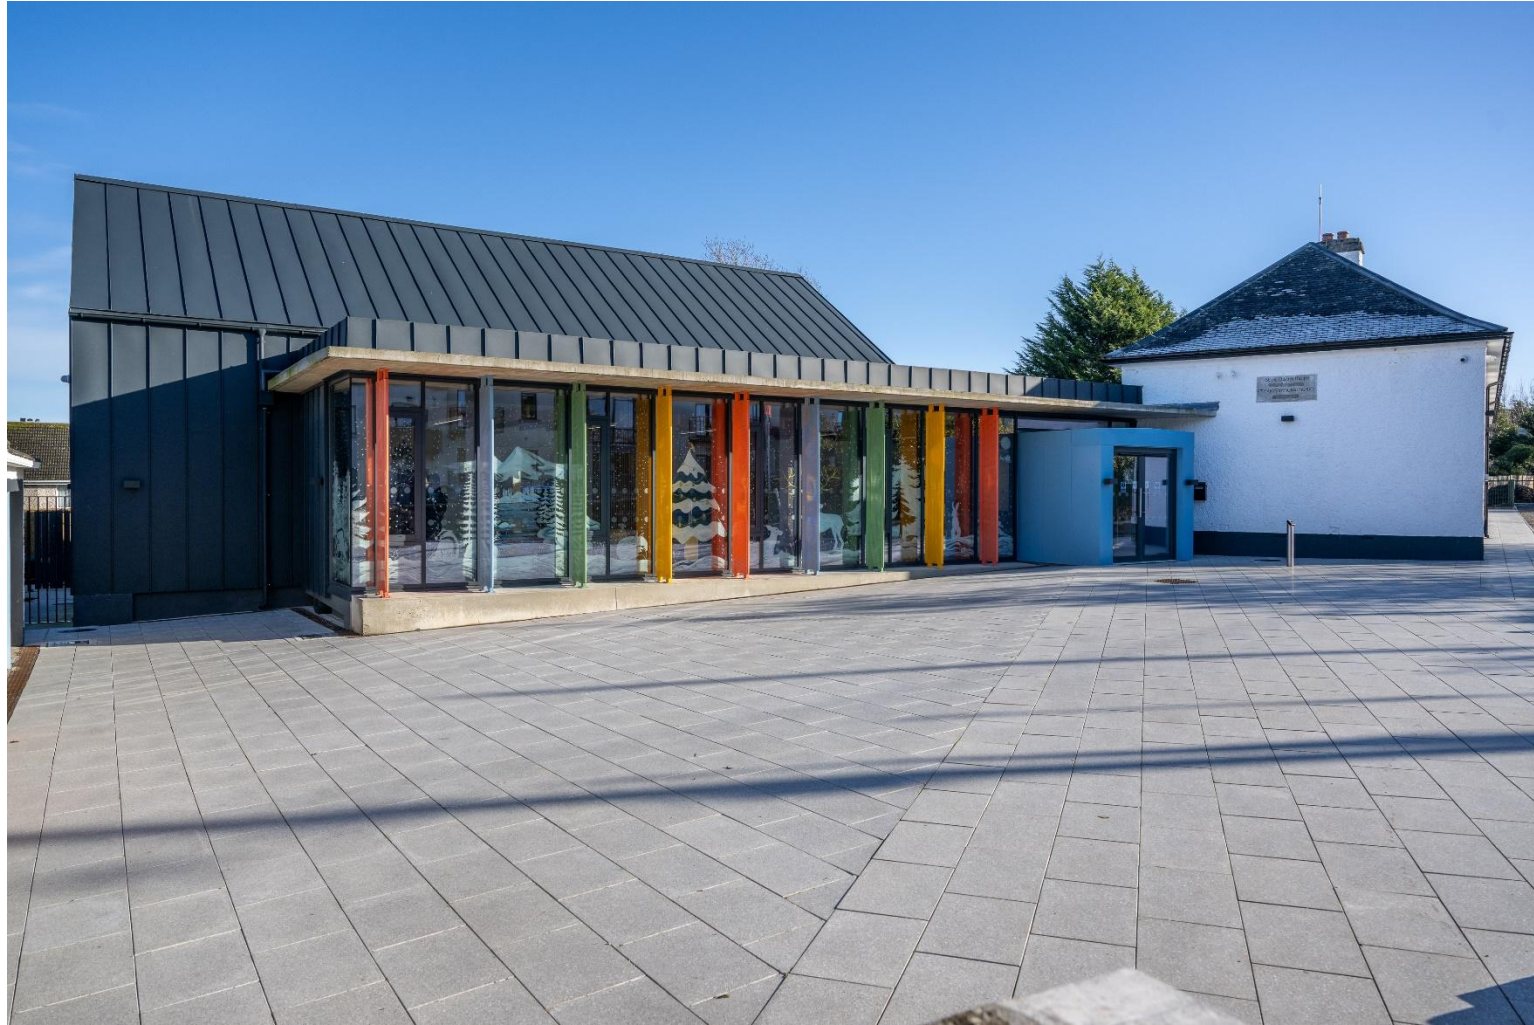
## Pitched Roof Design

The multi-function hall is designed with a pitched roof form to compliment its village setting while using contemporary materials and detailing

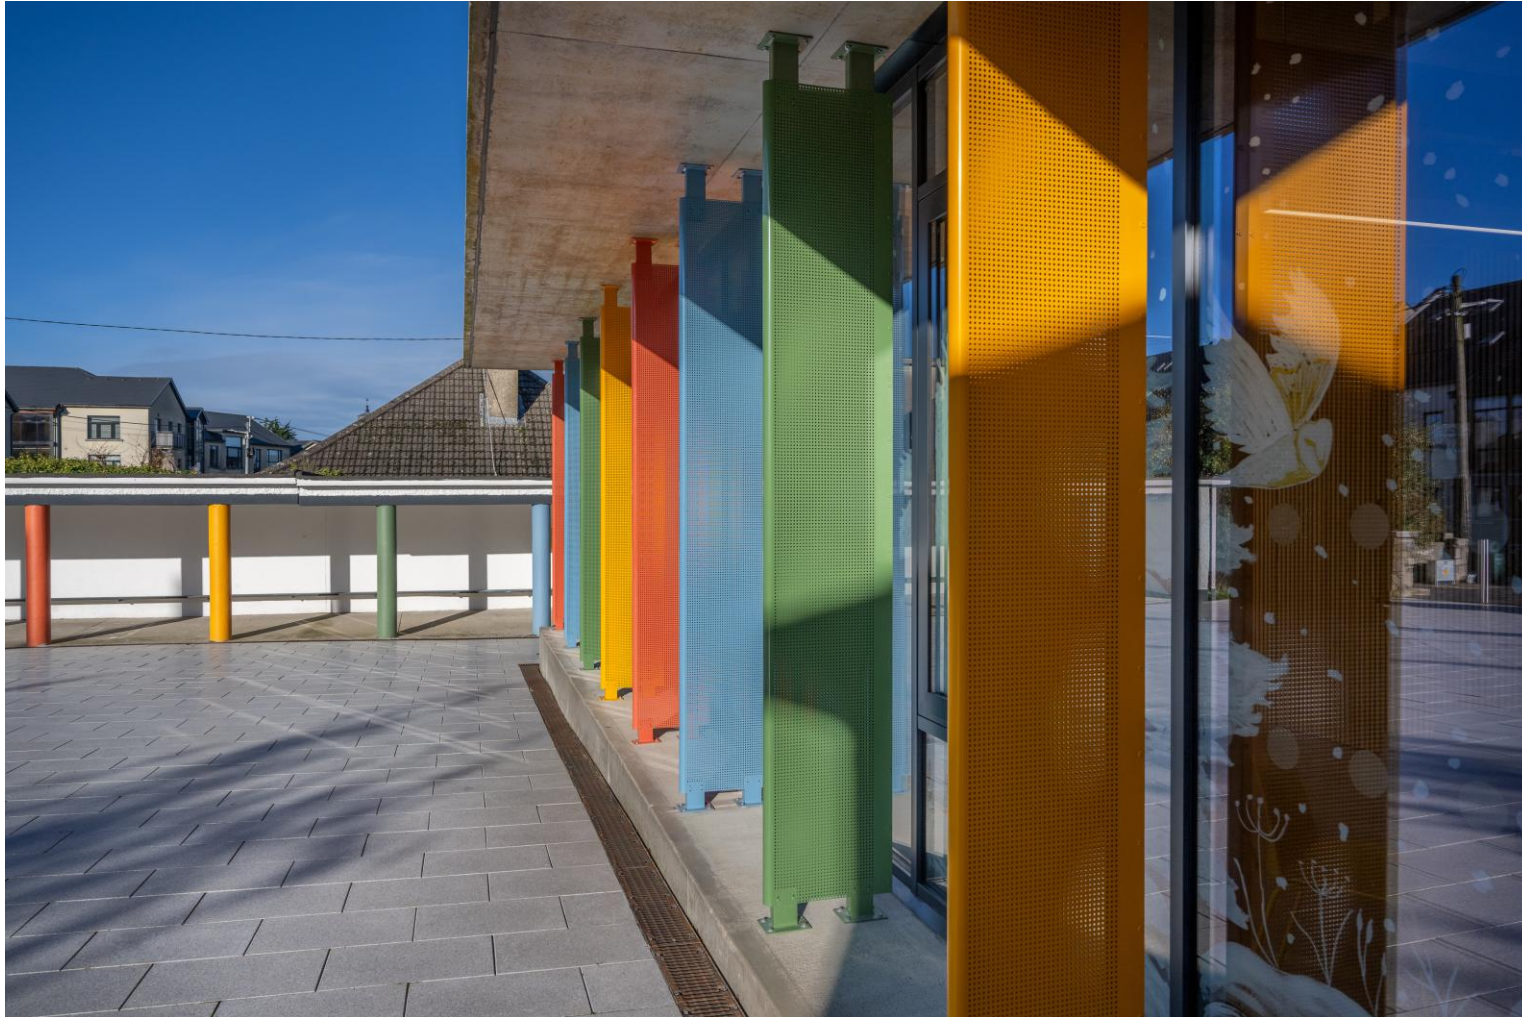
## Entrance Face

The new glazed entrance establishes the face of the building using a slim concrete canopy and colorful fins

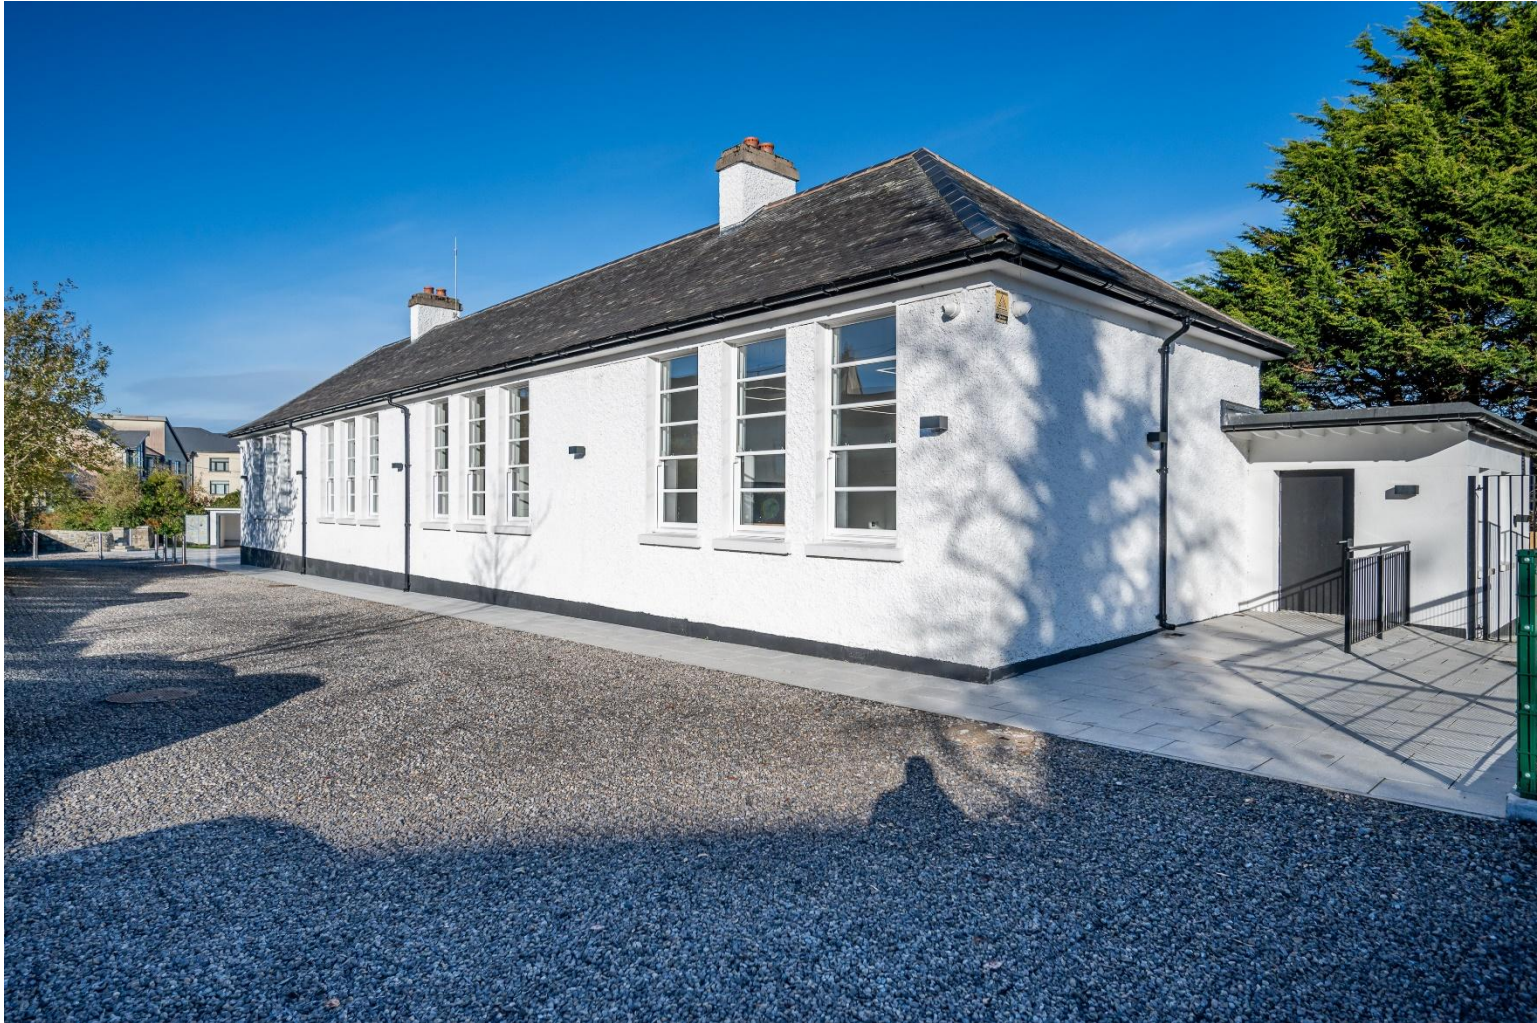
## Old School Restored

The old school building has been restored, upgraded and re-purposed in consultation with the SDCC Conservation Officer

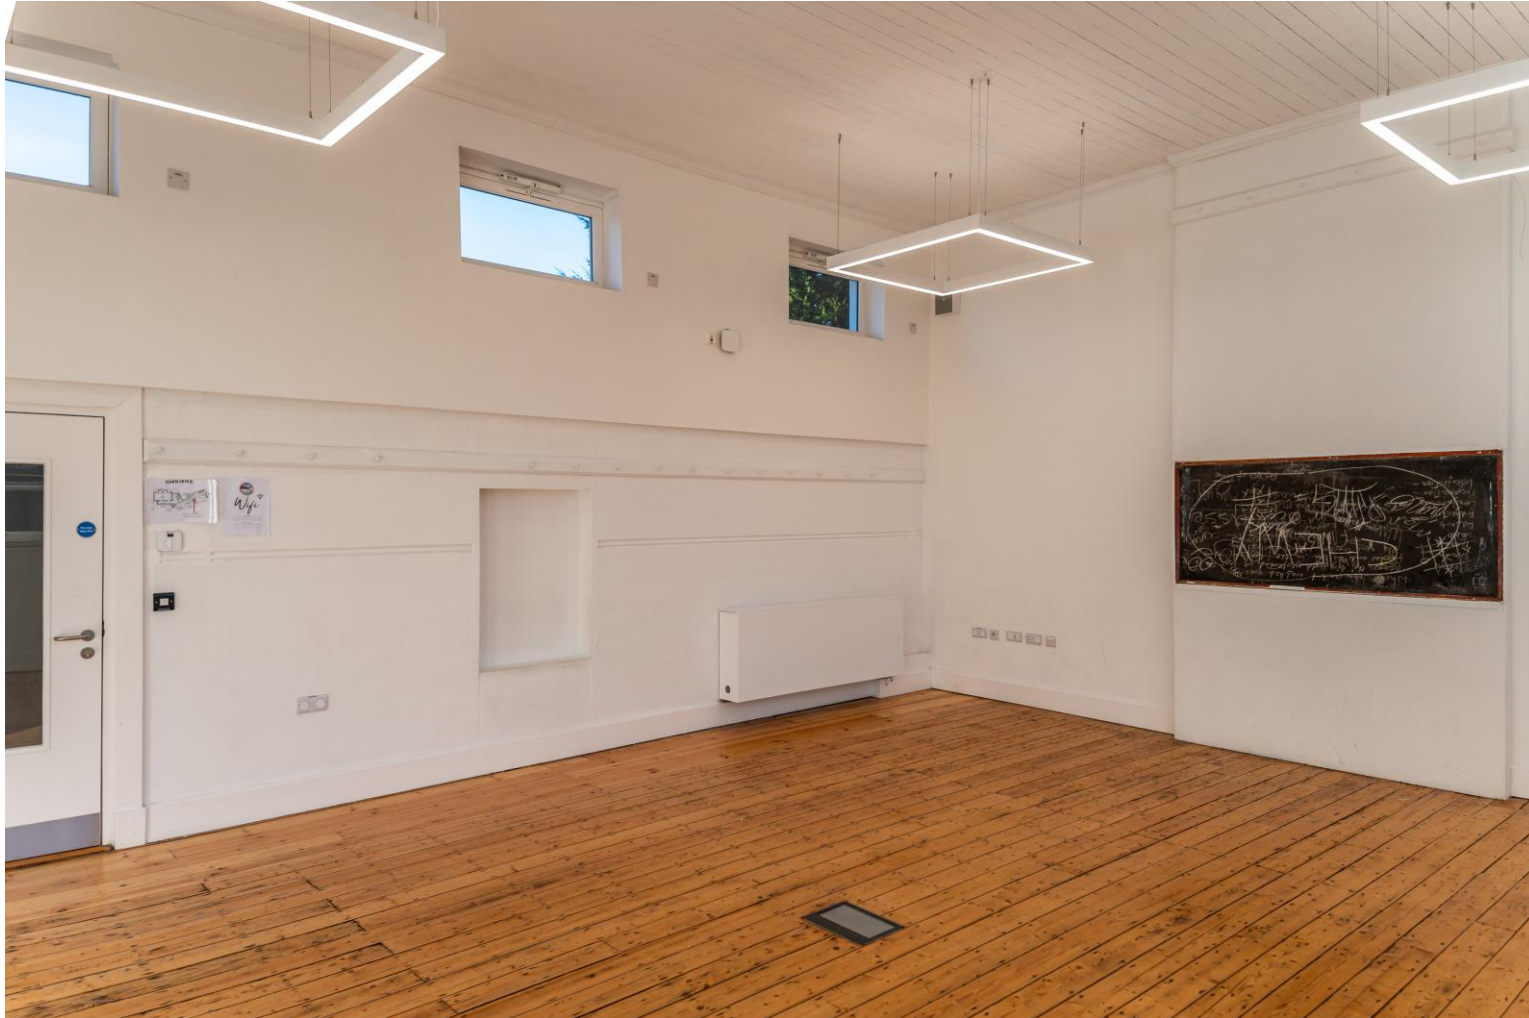
Original features have been retained and restored including Blackboards, timber flooring and timber ceiling

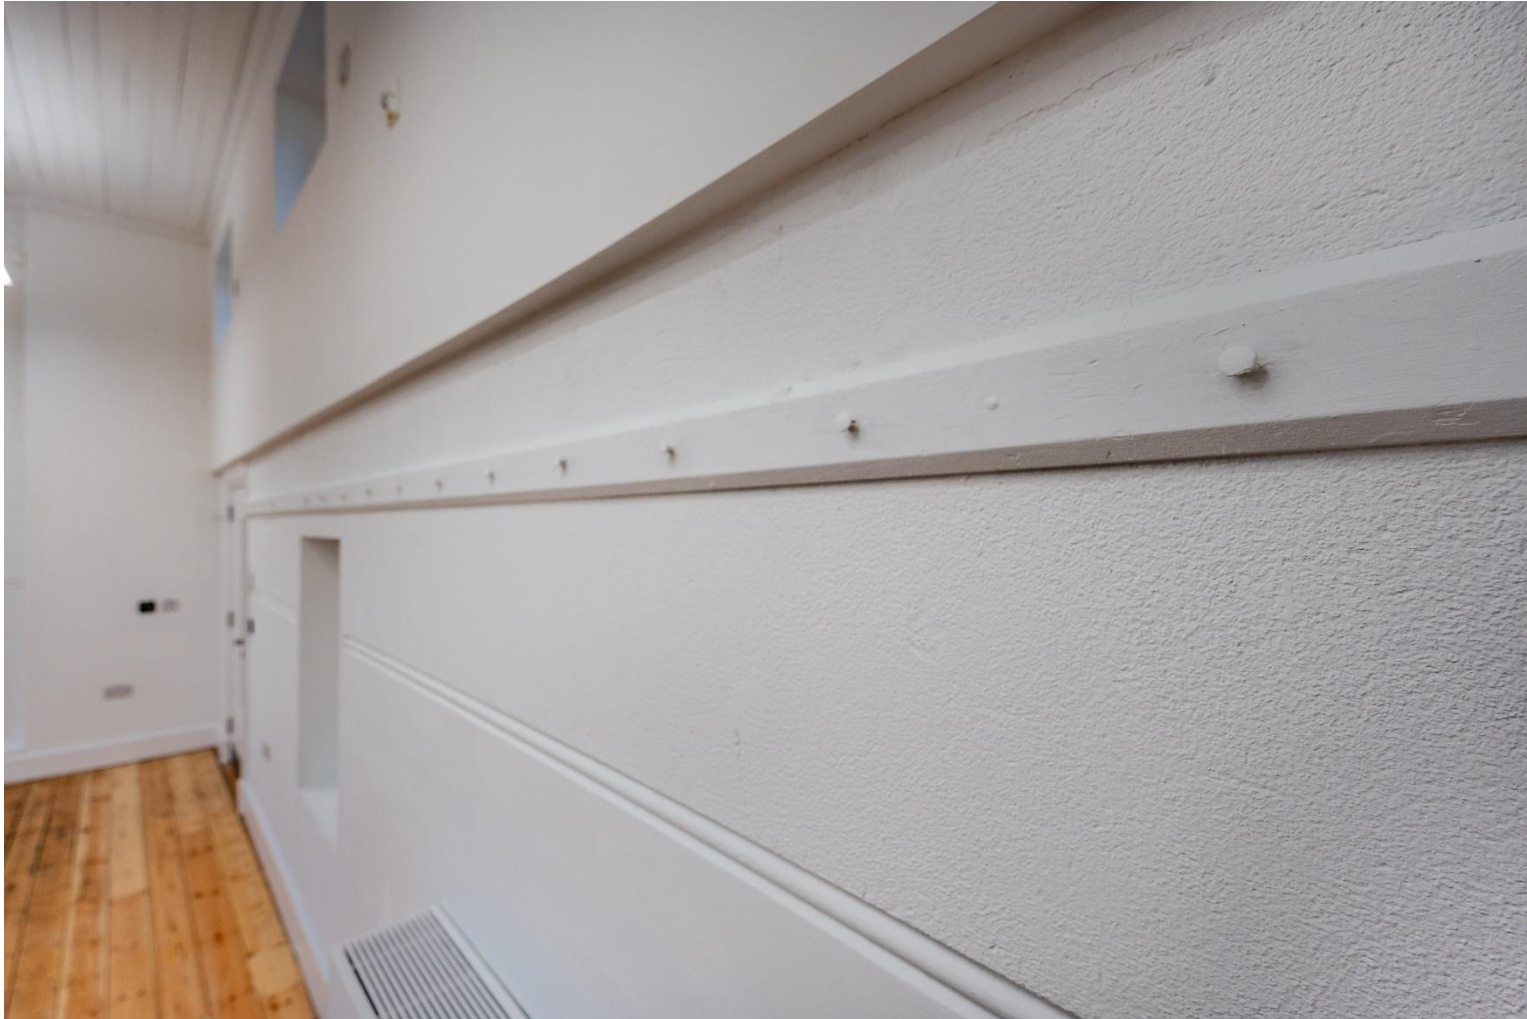
Map rails, cast dado rails and wall textures

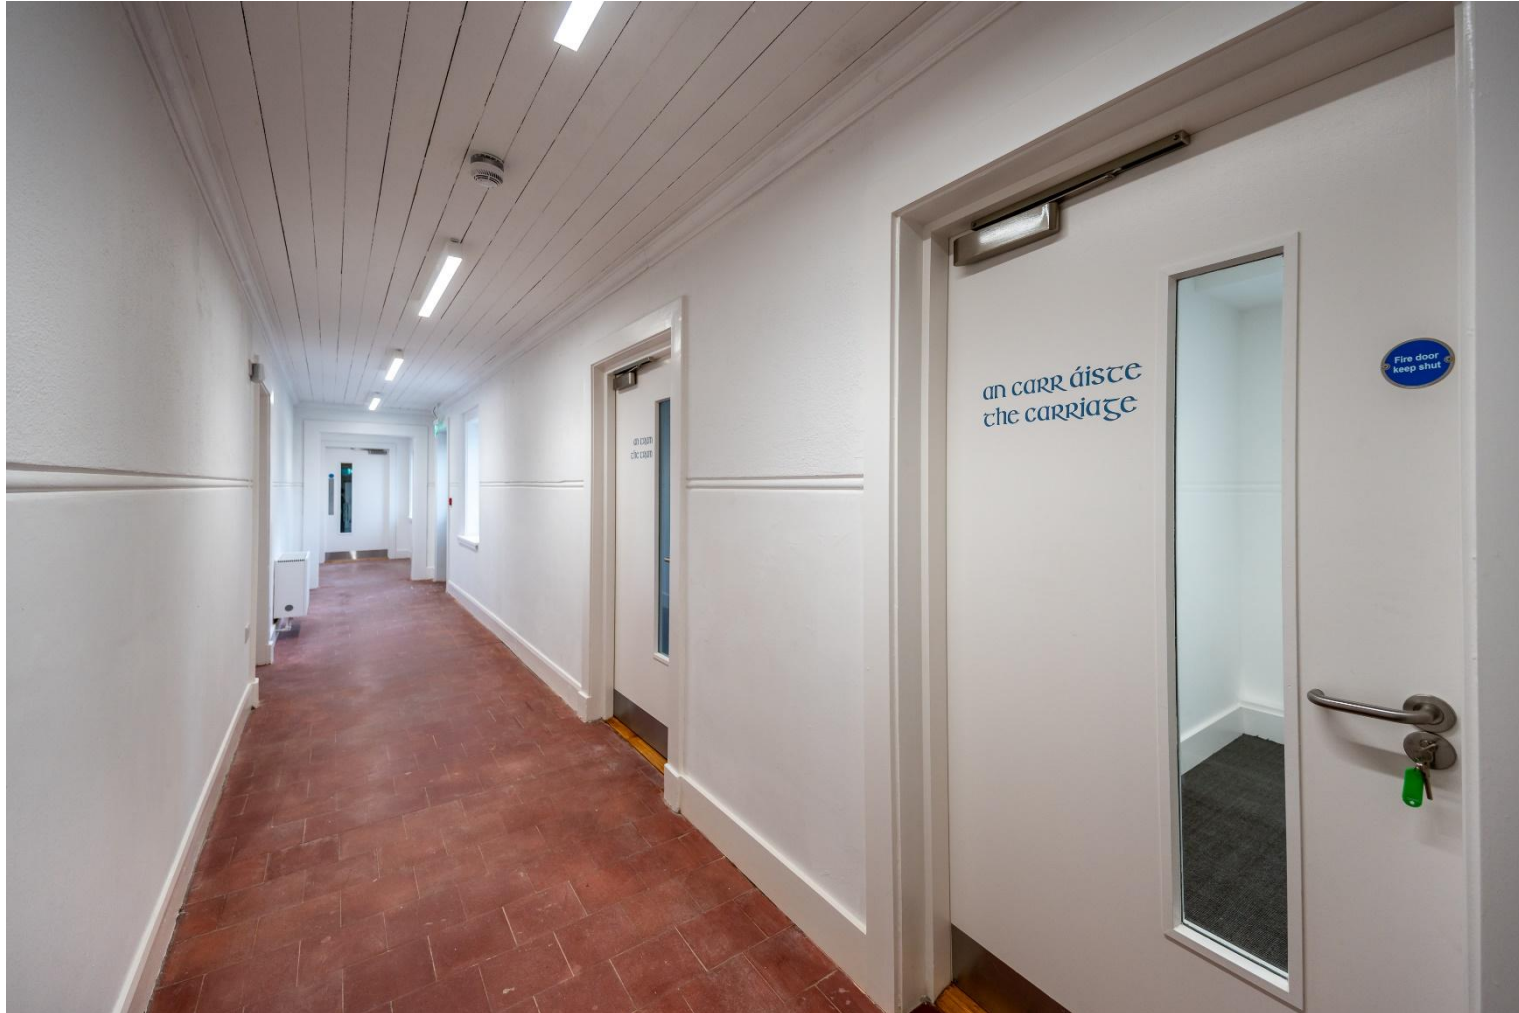
Corridor Floor Tiles have been retained and restored

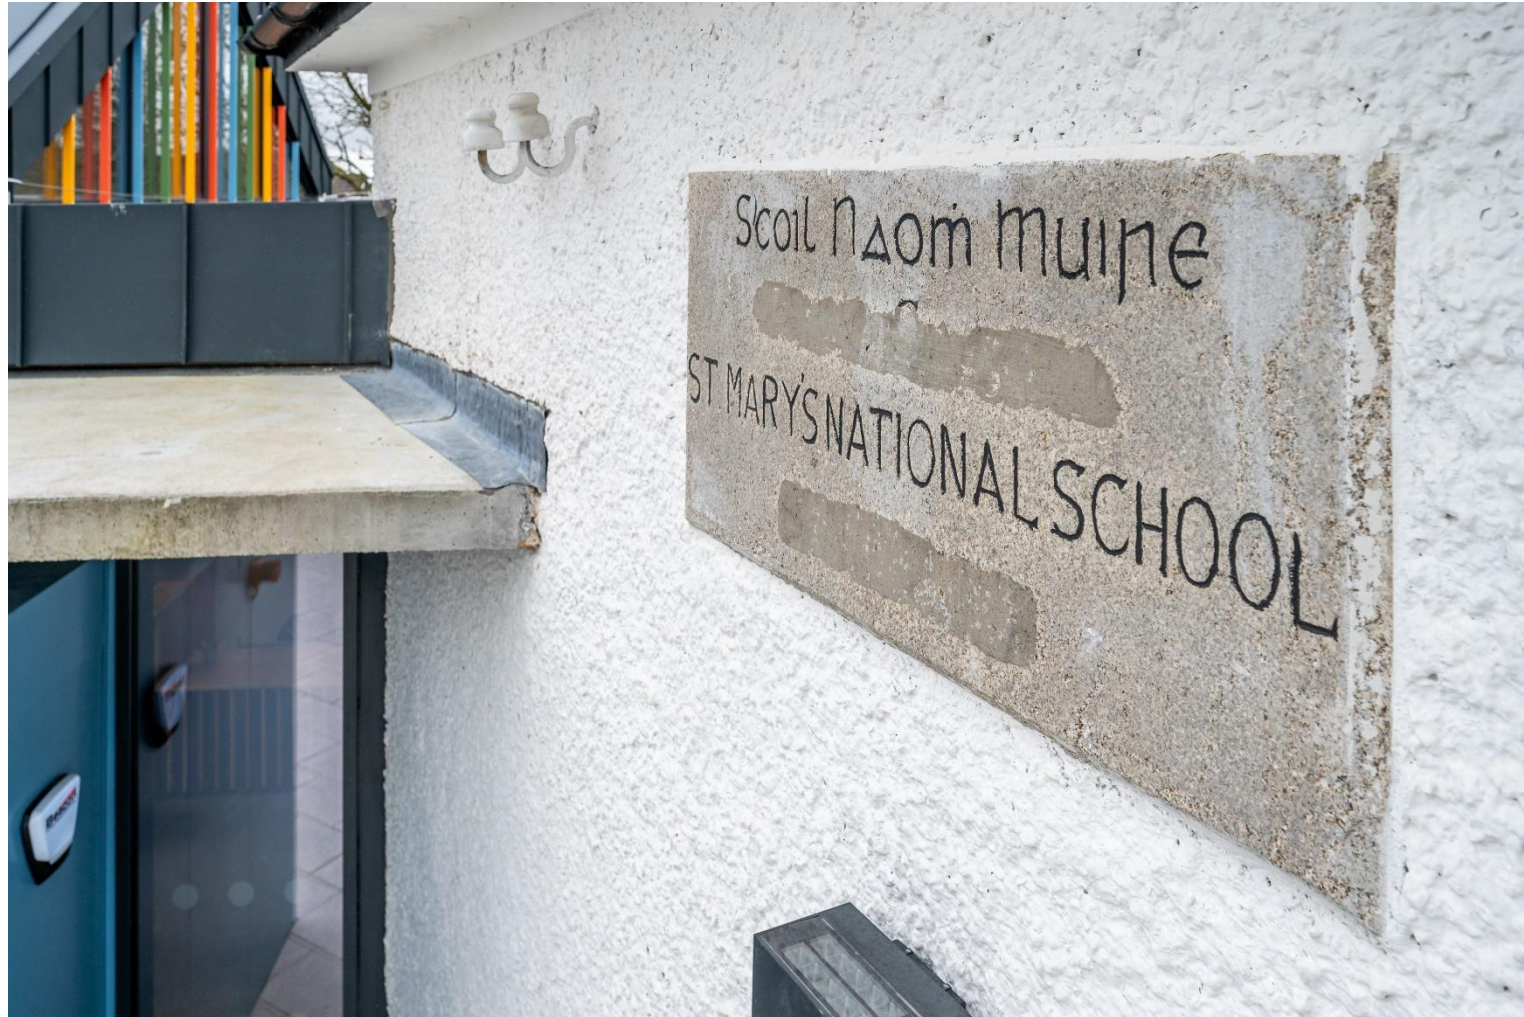
Original stone name plaques and threshold stones have been restored and reinstated  
These features maintain the distinctive schoolhouse character to the Community Centre

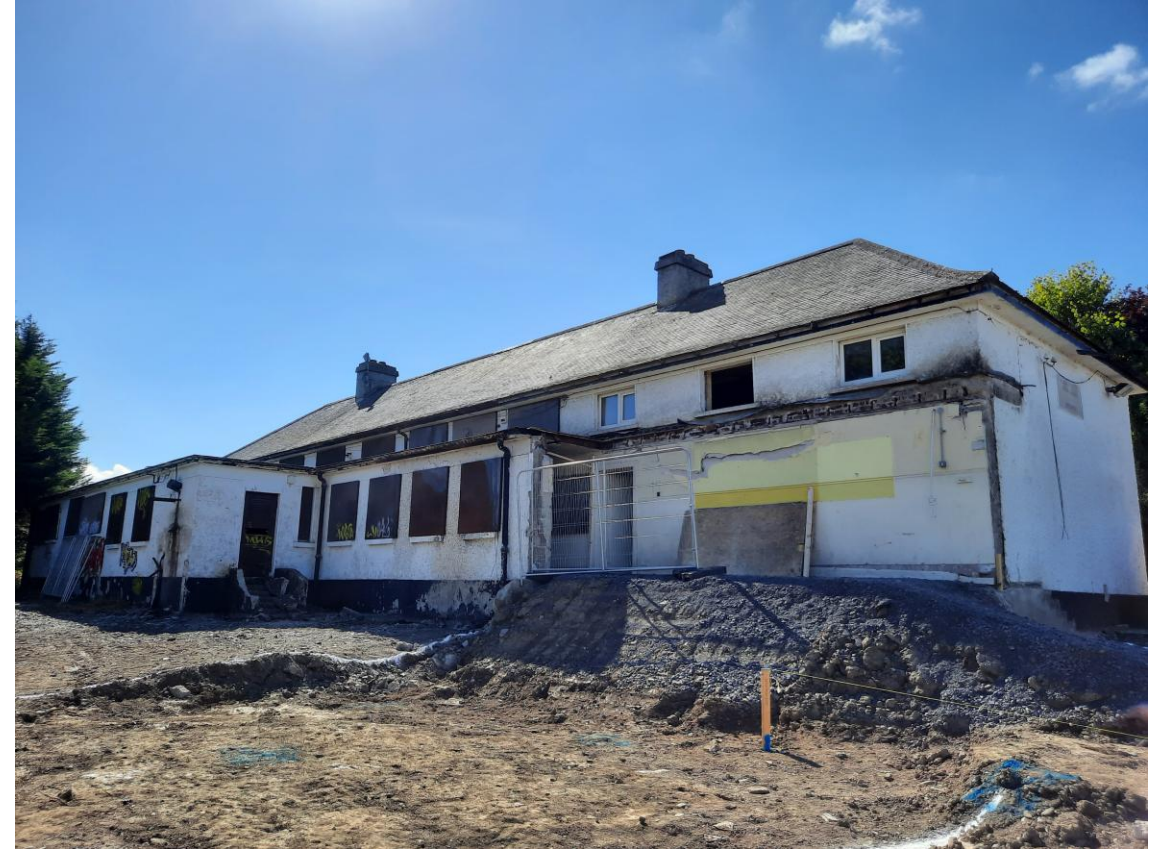
# Workmanship – Site Manager

- The Site Manager was not the one who's CV was provided in the contractor's tender
- The Site Manager damaged a section of the protected structure rear wall
- He had tried to remove some roof joists, that were embedded in the wall, with an excavator
- The ER issued a Defects Notice
- The Contractor had to provide a Method Statement of careful repair to the damaged wall
- He was shortly replaced by another Site Manager
- We requested a CV but this was not forthcoming

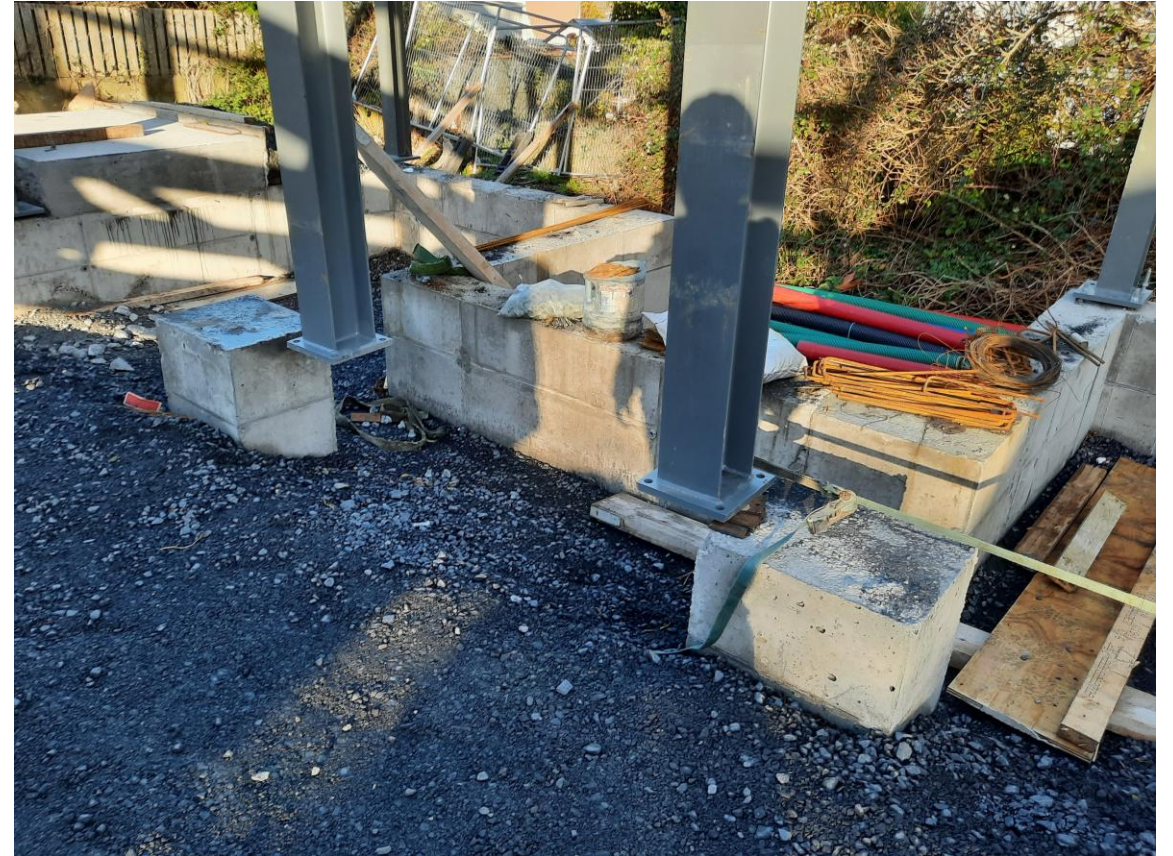
# Workmanship – Structure

- The new main hall has a steel frame structure
- When erected the steel columns were alarmingly misaligned with the associated concrete footings
- The ER issued a Defects Notice and instructed the Contractor to provide an as-built survey
- If there are significant concerns about workmanship, work cannot progress until it has been rectified

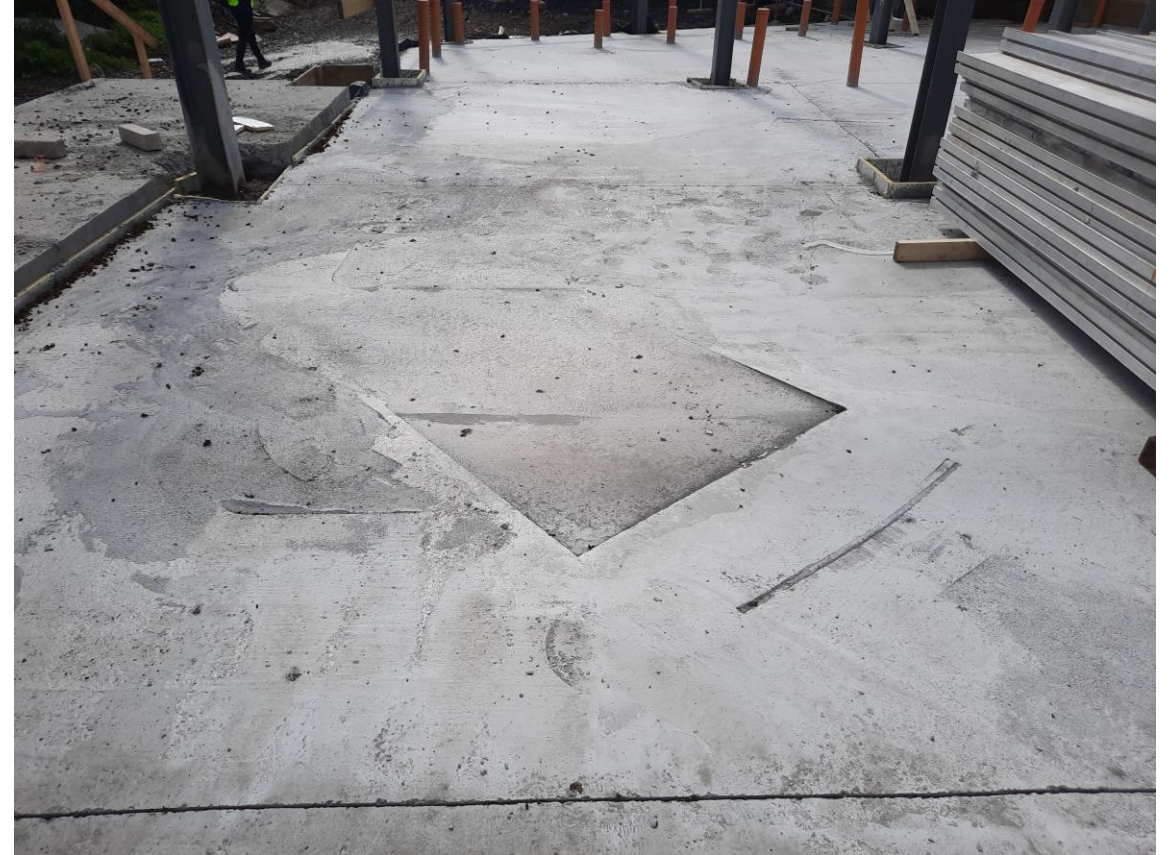
# Workmanship – Concrete

- The contractor poured the structural floor slab and we were alarmed by the poor quality of finish.
- It was uneven underfoot and there was even a boot mark evident in the slab
- As this slab was to be covered by insulation and underfloor heating screed, the poor appearance was not critical

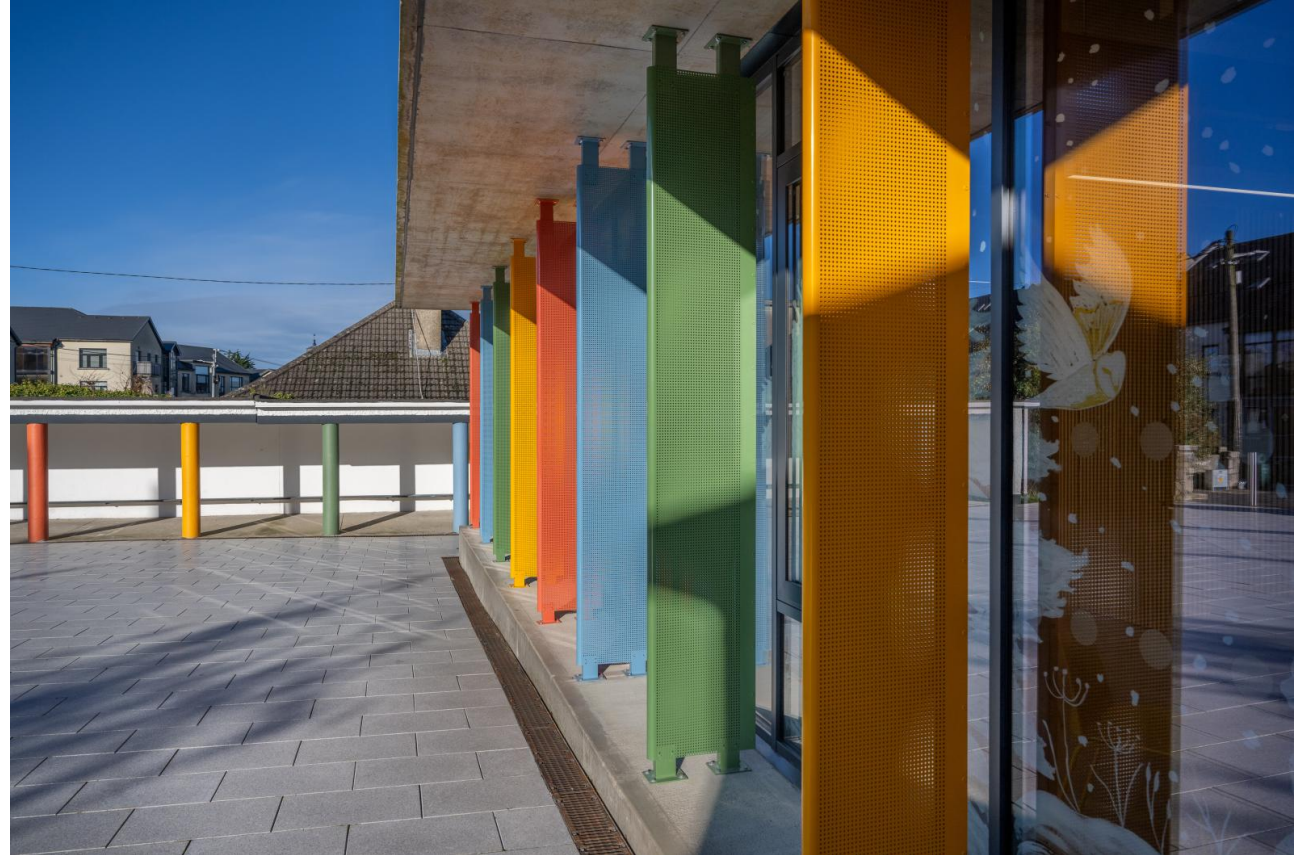
# Workmanship – Concrete

- An exposed concrete entrance canopy and soffit was a central part of the design
- High quality workmanship is critical to achieving satisfactory exposed concrete
- From the worrying experience of the floor slab we insisted that they provide a bench mark sample for approval before proceeding with the concrete canopy
- They engaged a specialist sub-contractor and produced an approved benchmark
- Due to the bench mark process a very successful slim and well finished canopy and soffit were achieved much to our relief

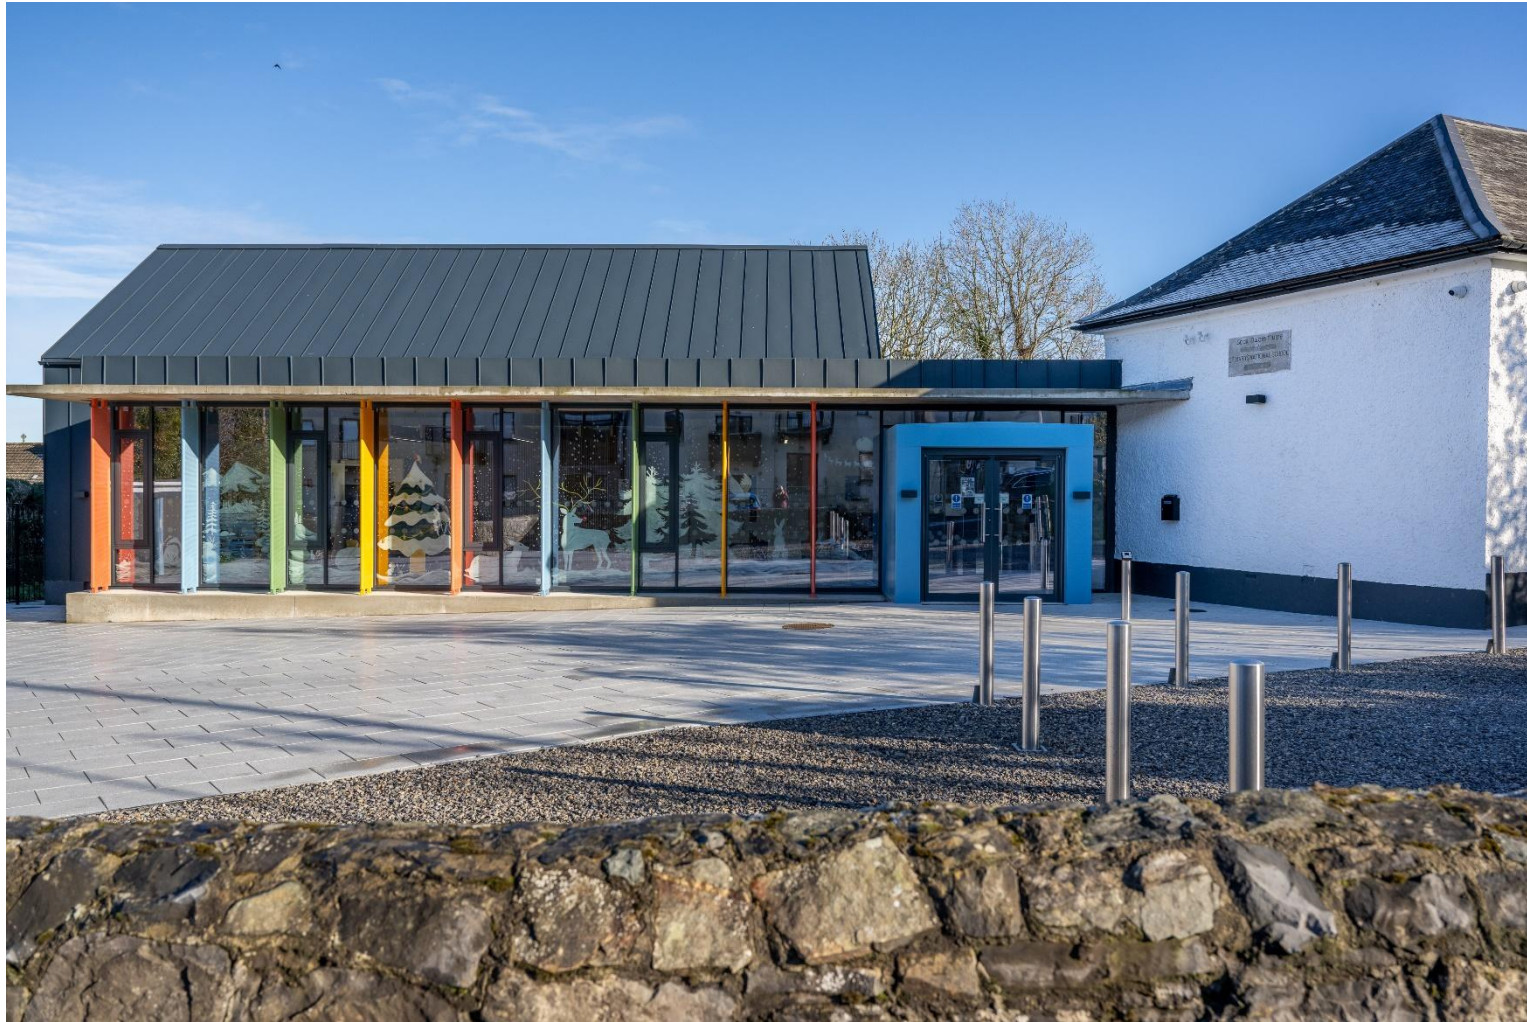
## Level Access

The New Entrance has been set at the lower ground level of the site to provide level access

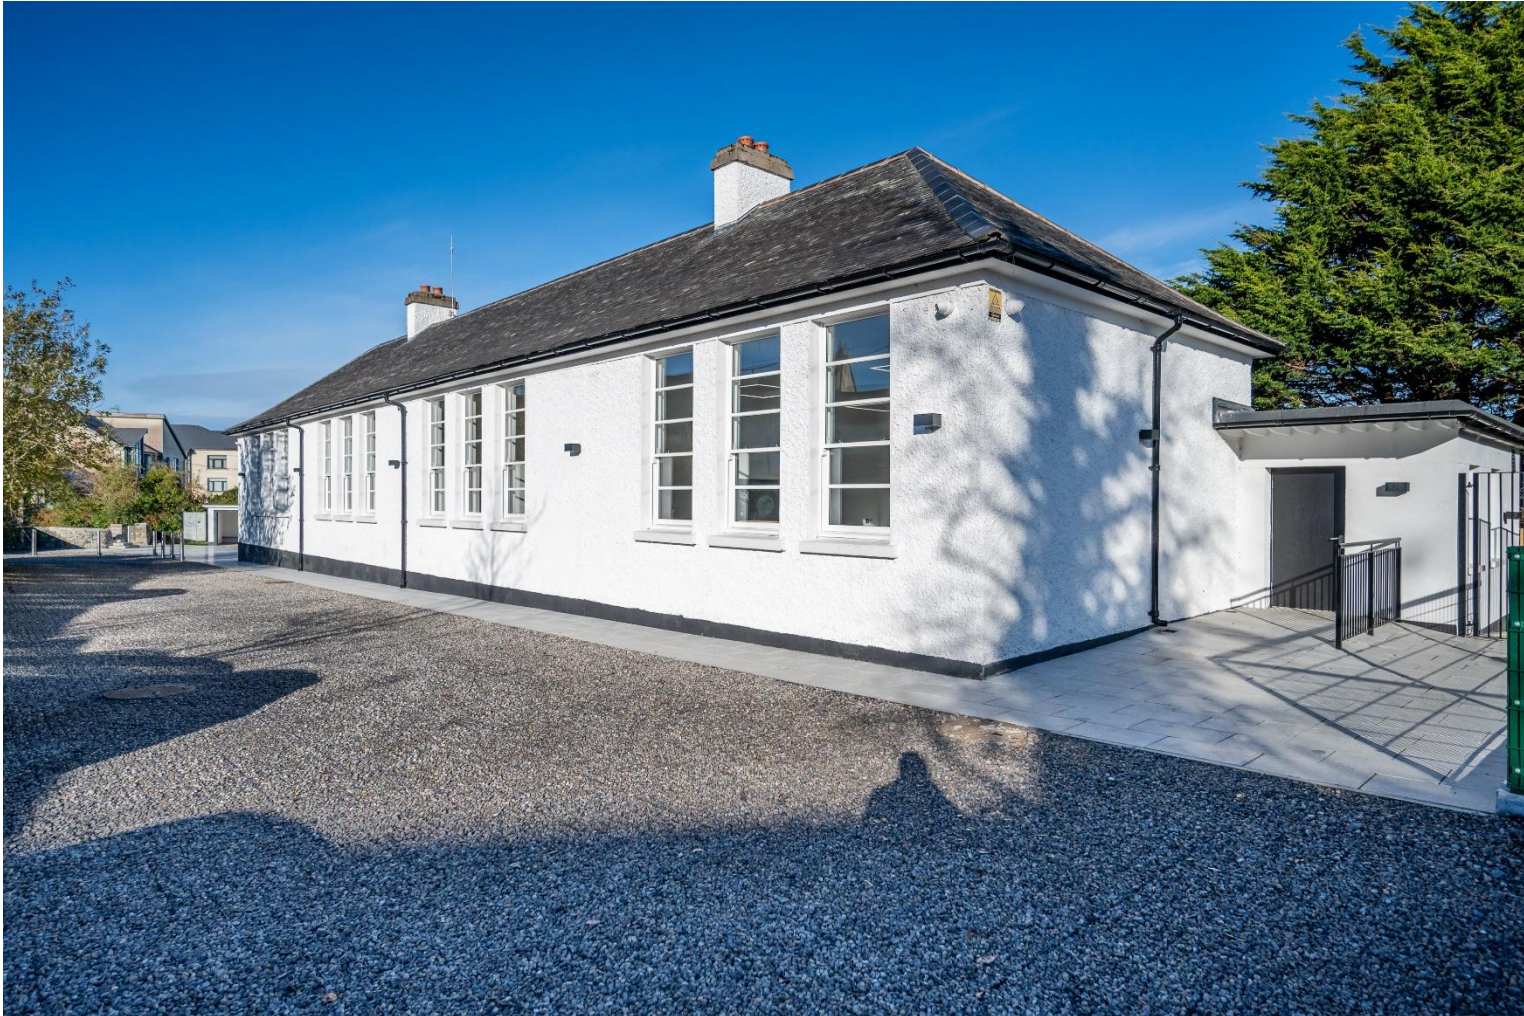
## Level Access

Also accessible at the upper end of the site working with the gently sloping topography

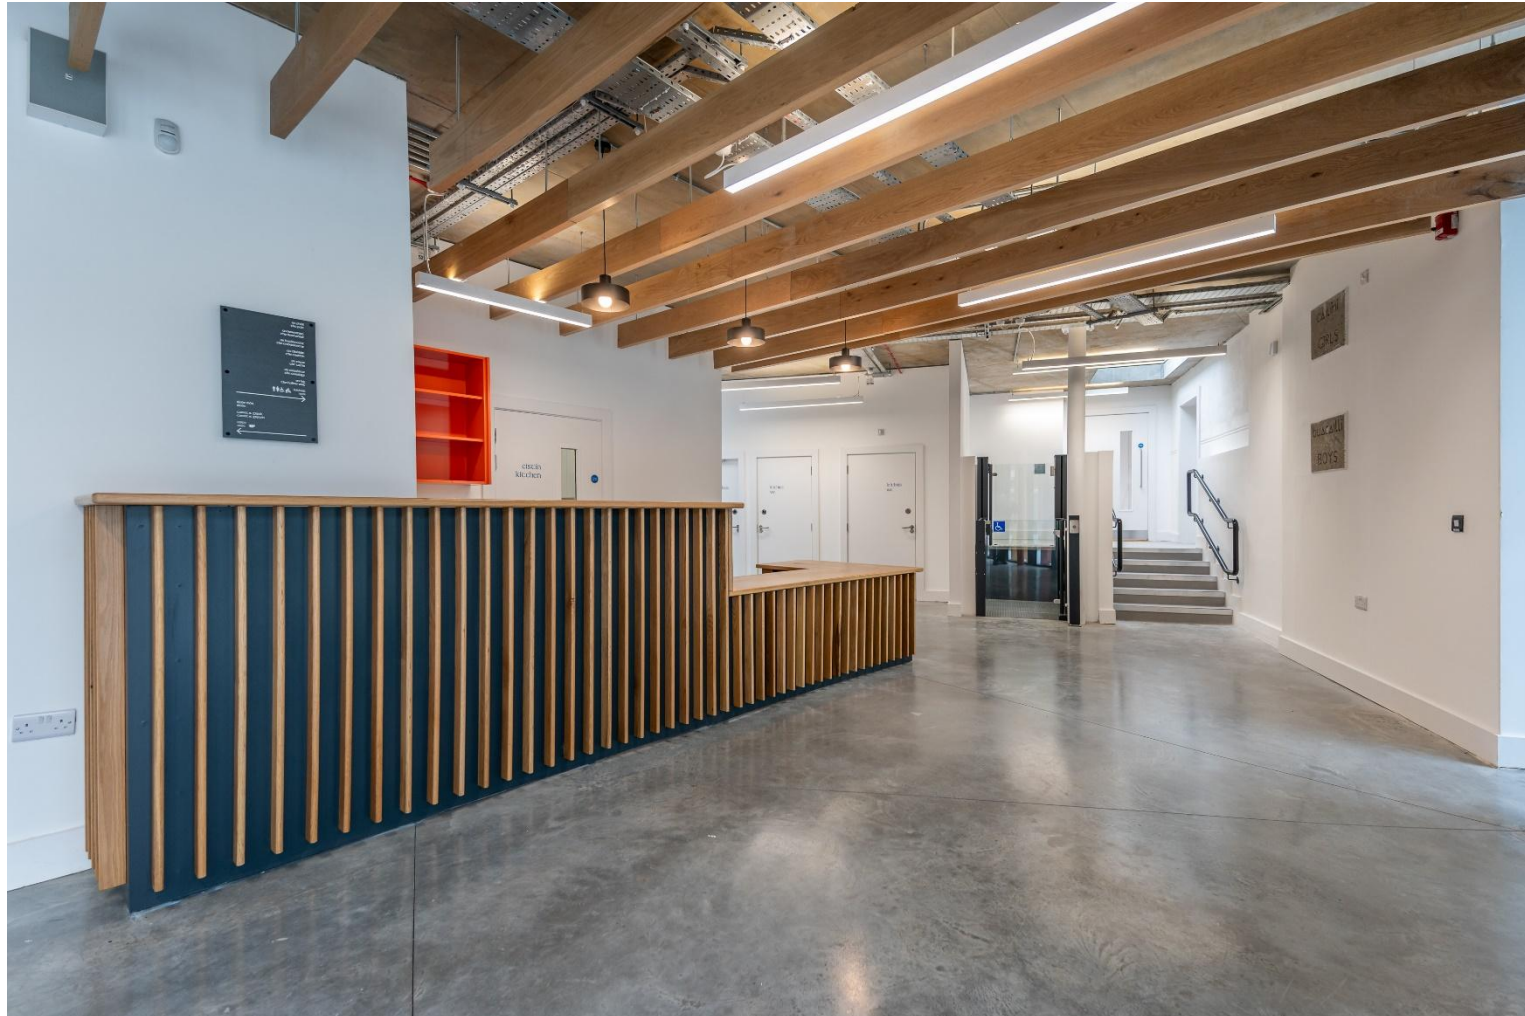
## Transition

Accessible steps and platform lift make the transition within the new area to the Protected Structure
