South Dublin  
County Council

# Case Study: Saggart Schoolhouse Community Centre

JUNE 2025

Presented by  
Aidan McNamara

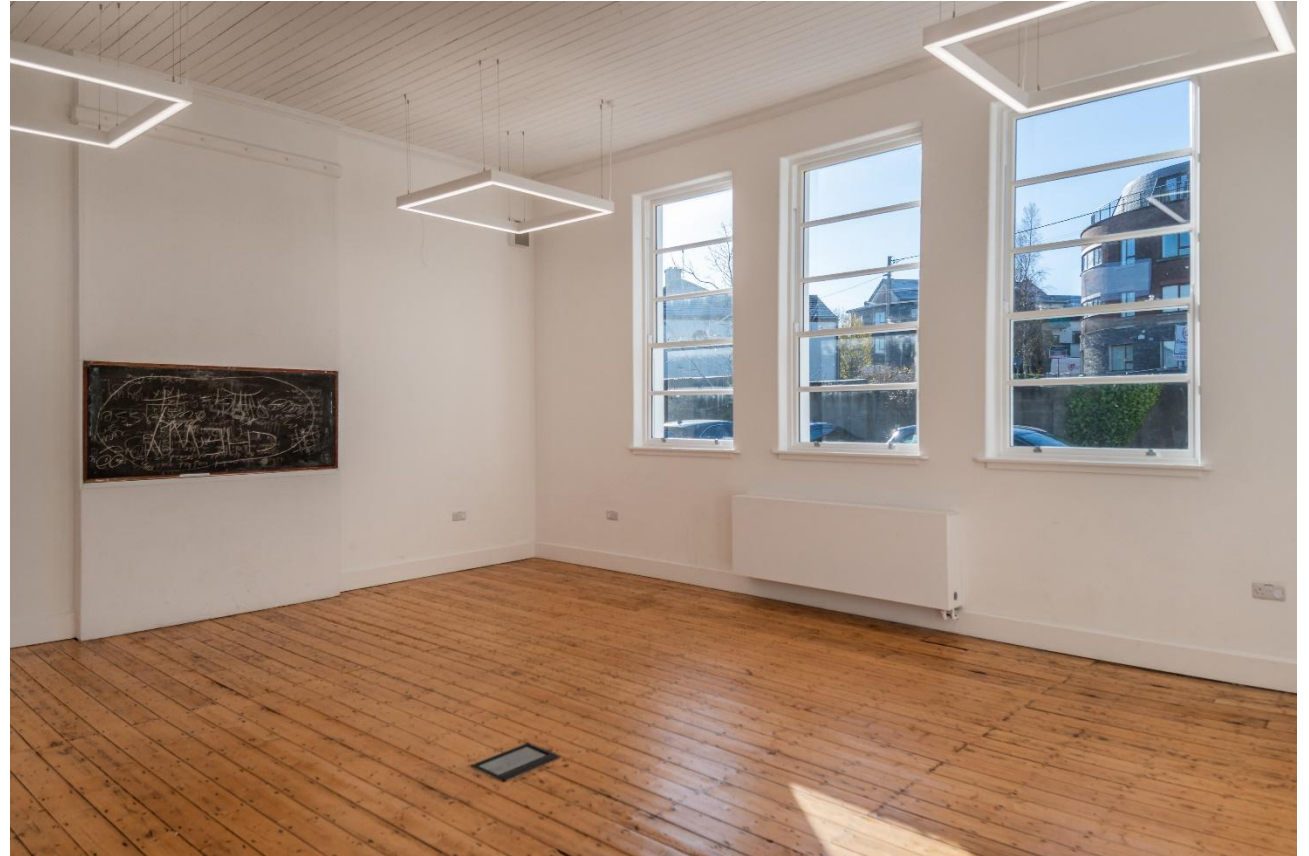
# Insulation

- A practical insulation strategy was agreed with the Conservation Officer to balance conservation and energy efficiency.
- The prominent front classroom building is internally insulated with breathable Calistherm insulation.

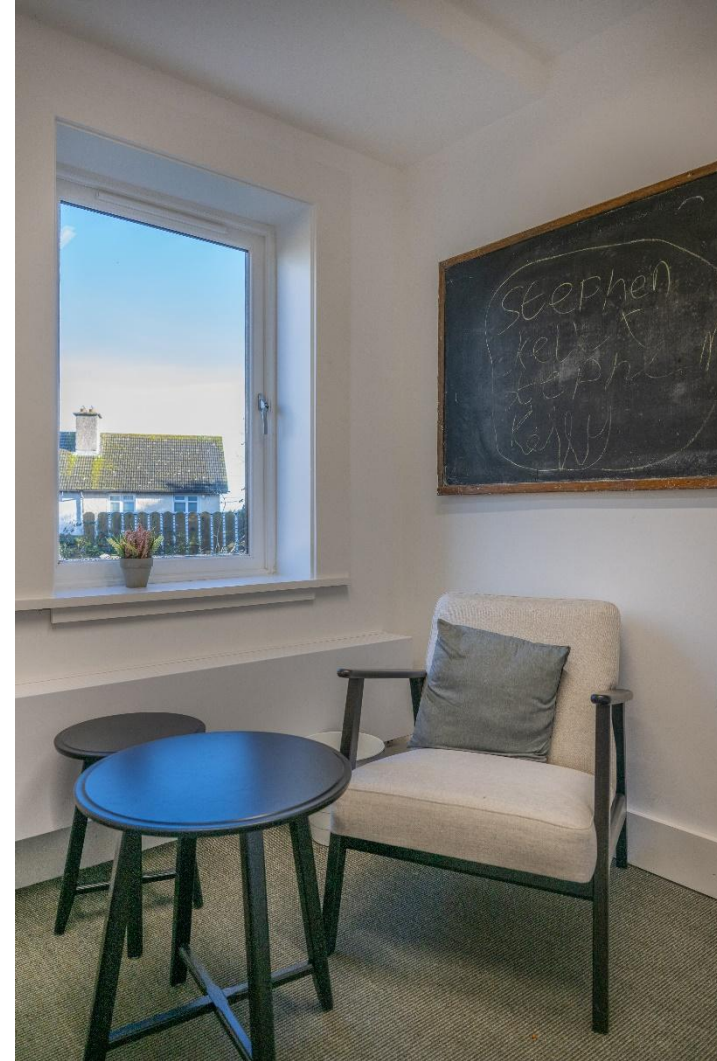
# Insulation

- The less visible rear service wing is externally insulated to optimize effective insulation and maximise the small room sizes.
- The building has also been sealed for airtightness.

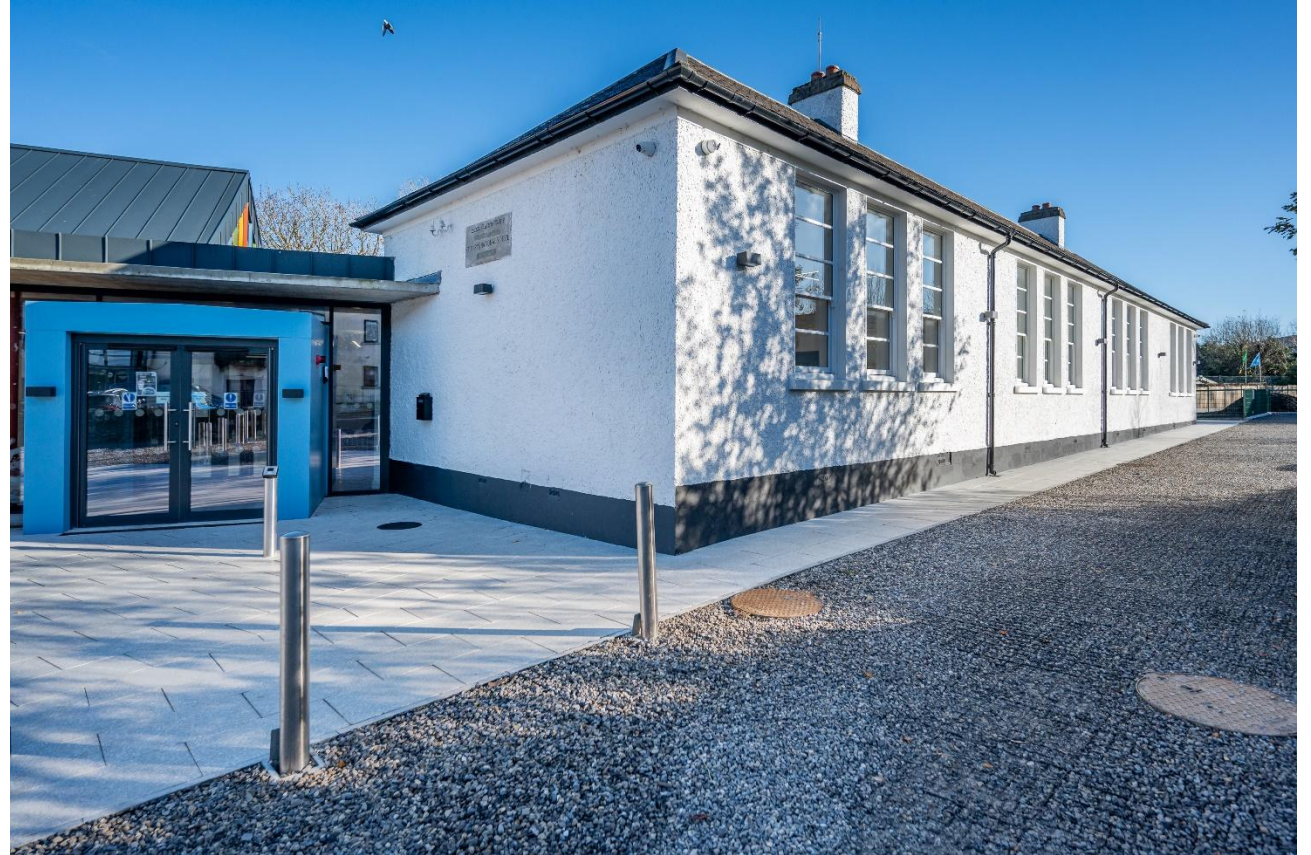
# Surface Water

- The site has been designed to be self sufficient in surface water management
- Site was largely covered in impermeable tarmac
- We removed and replaced this with softer more permeable surfaces where practical
- Focused paved areas on the public and service spaces
- Provided a sedum roof on the new flat roof area for rainwater attenuation
